Bid Number: 22-57-1620	Title: Shady Grove Bathhouse Roof Replacement
	Date: 6/2/22
Issuing Officer: Kimber Carder	Bid Initially Solicited: 5/20/22
Email Address: kncarder@forsythco.com	Telephone: 770-888-8872

Bathroom A Inspection Report

Forsyth County Public Maintenance
Shady Grove Bathhouse A
7800 Allyn Lane Memorial Way, Cumming, GA

C.L.BURKS
ROOF REPORT

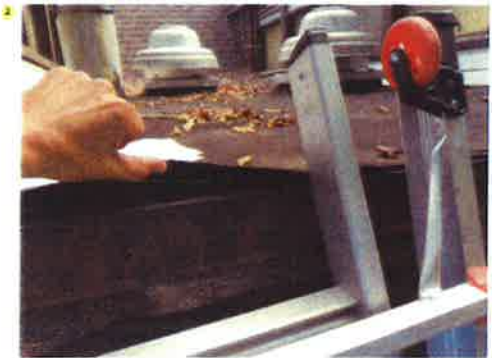
General - Metal Edge Failure (Emergency)

Quantity: 10 LF

Deficiency:
Roof membrane has separated from the edge metal allowing water intrusion into the building at the perimeter.

Corrective Action:
The affected area should be cleaned, primed, and patched per industry standards to provide a watertight seal at the perimeter.

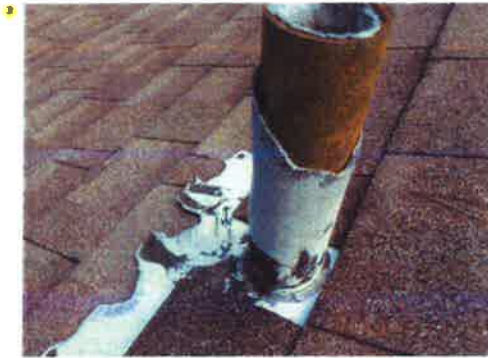
General - Penetration Failure (Emergency)

Quantity: 3 EA

Possible water intrusion at roof penetration.

The penetration should be resealed/flashed per industry standards to ensure a water tight seal.

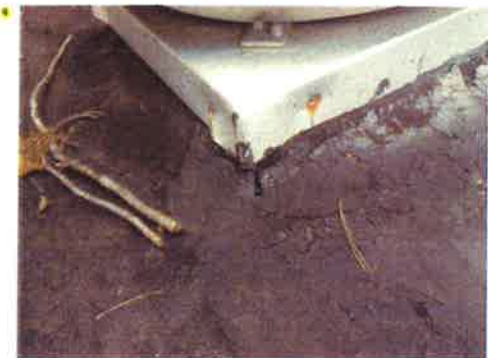
General - Open Membrane Curb Corner (Emergency)

Quantity: 2 EA

Membrane flashing is open at the curb corner(s).

Repair failing membrane flashing on the corner of the curb per industry standards.

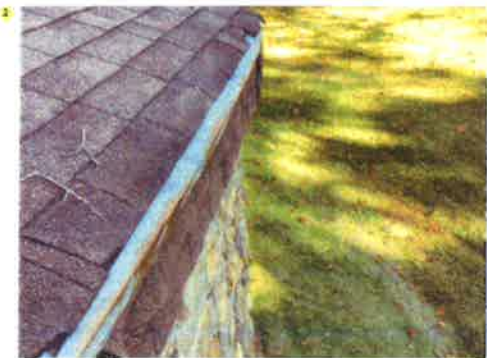
General - Metal Edge Failure (Emergency)

Quantity: 75 LF

drip edge metal has come loose.

reattach drip edge.

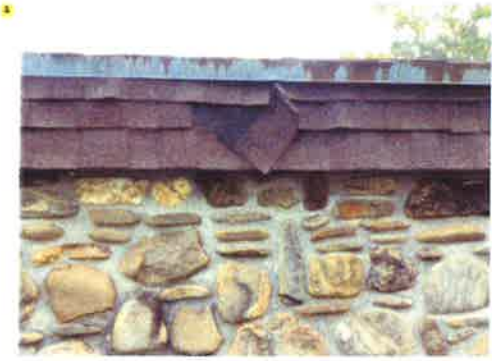
General - Loose or Detached Shingles (Emergency)

Quantity: 12 EA

Loose or detached shingles.

Reattach shingles.

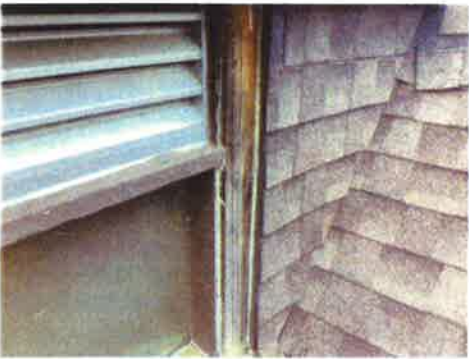
General - Caulking Failure (Emergency)

Quantity: 150 LF

Existing caulking or sealant is deteriorated and is no longer providing a water tight seal.

We will remove the old caulking, clean and prime the areas that are failing, then apply new waterproofing sealant per industry standard to provide a water-tight seal.

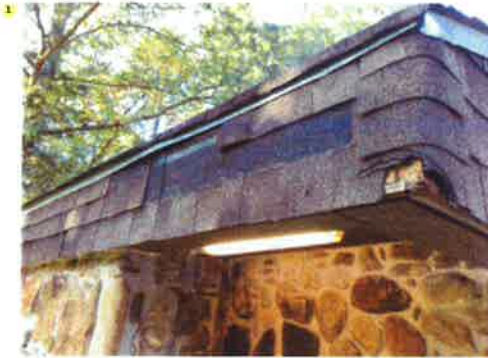
General - Missing Shingles (Remedial)

Quantity: 12 EA
Deficiency:
Missing Shingles
Corrective Action:
Add shingles where it is needed.

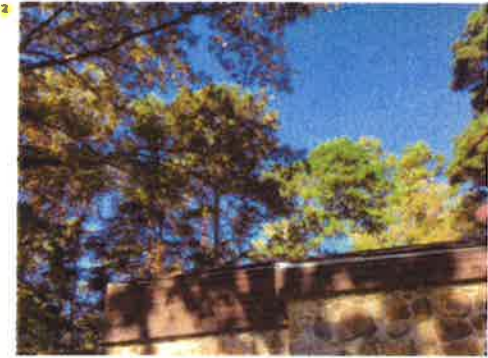
General - Trees Overhanging on Roof (Remedial)

Quantity: 1 EA
Deficiency:
Trees overhanging roof.
Corrective Action:
Cut/trim trees back away from building.

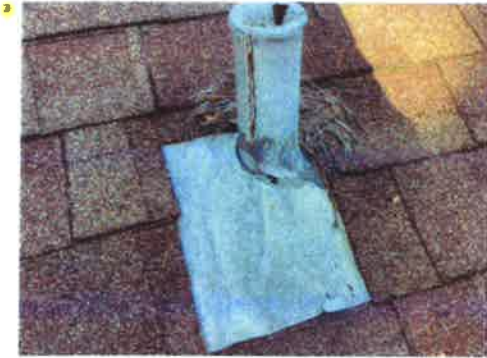
General - Penetration Failure (Emergency)

Quantity: 3 EA

Possible water intrusion at roof penetration.

The penetration should be resealed/flushed per industry standards to ensure a water tight seal.

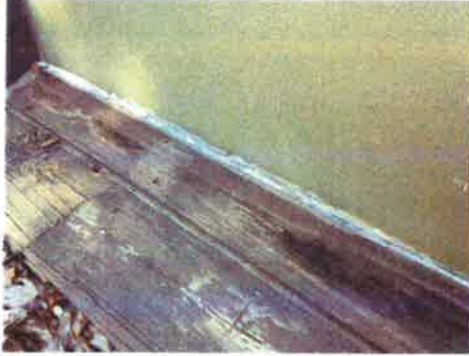
General - Caulking Failure (Remedial)

Quantity: 150 LF

Existing caulking or sealant is deteriorated and is no longer providing a water tight seal.

We will remove the old caulking, clean and prime the areas that are failing, then apply new waterproofing sealant per industry standard to provide a water-tight seal.

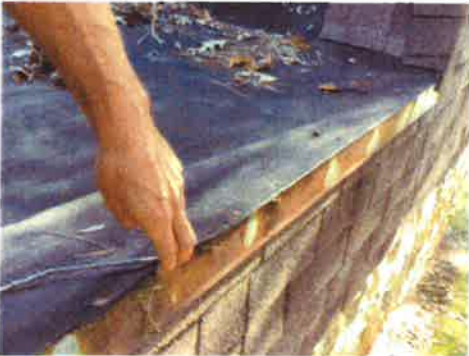
General - Metal Edge Failure (Remedial)

Quantity: 75 LF

Roof membrane has separated from the edge metal allowing water intrusion into the building at the perimeter.

The affected area should be cleaned, primed, and patched per industry standards to provide a watertight seal at the perimeter.
