Bid Number: 22-57-1620	Title: Shady Grove Bathhouse Roof Replacement
	Date: 6/2/22
Issuing Officer: Kimber Carder	Bid Initially Solicited: 5/20/22
Email Address: kncarder@forsythco.com	Telephone: 770-888-8872

Bathroom A Inspection Report

Forsyth County Public Maintenance
Shady Grove Bathhouse A
7800 Allyn Lane Memorial Way, Cumming, GA

C.L.BURKS
ROOF REPORT

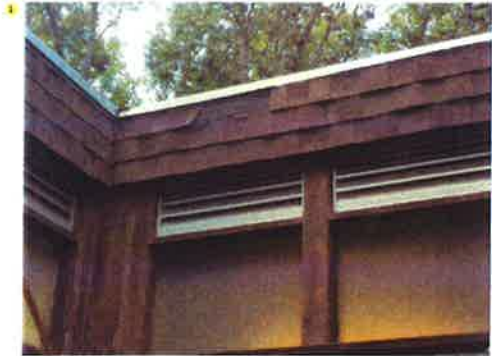
Shingle Roof - Holes - Punctures - Rips - Tears - Splits (Emergency)

Quantity: 25 EA

Deficiency:
Ripped/missing shingle

Corrective Action:
The area surrounding the deficiency should be cleaned, and a new shingle should be installed

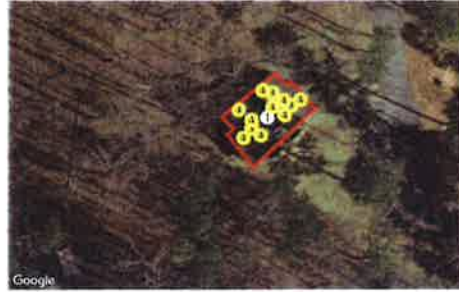
General - Penetration Failure (Emergency)

Quantity: 3 EA

Deficiency:

Possible water intrusion at roof penetration.

Corrective Action:

The penetration should be resealed/flashed per industry standards to ensure a water tight seal.

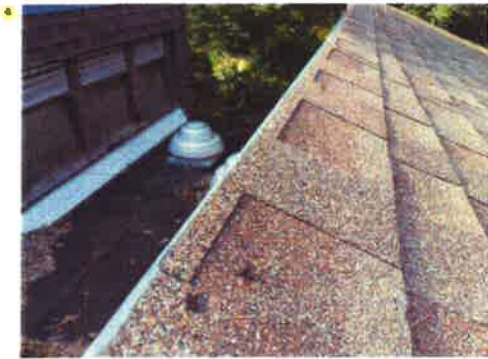
General - Exposed Nails (Emergency)

Quantity: 150 EA

Deficiency:

Exposed nails

Corrective Action:

Drive in nail and apply sealant

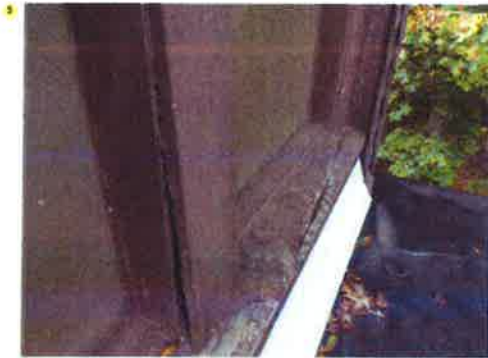
General - Rotten Wood (Remedial)

Quantity: 90 LF

Deficiency:

Wooden window frames are dry rotted.

Corrective Action:

Replace all rotted wood. (Monitor item)

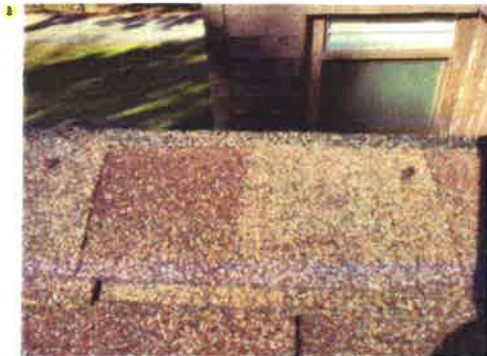
General - Exposed Nails (Emergency)

Quantity: 125 EA

exposed nails

Drive nails back in and apply sealant

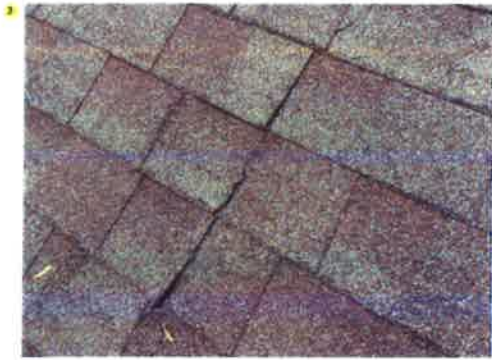
General - Holes - Punctures - Rips - Tears - Splits (Remedial)

Quantity: 20 EA

Hole(s)/Splits/Tears found in shingles.

Apply sealant as temporary repair until roof can be replaced

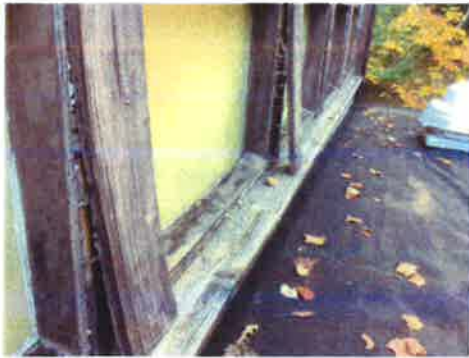
General - Rotten Wood (Emergency)

Quantity: 90 LF

All wood needs to be replaced. (Monitor item)

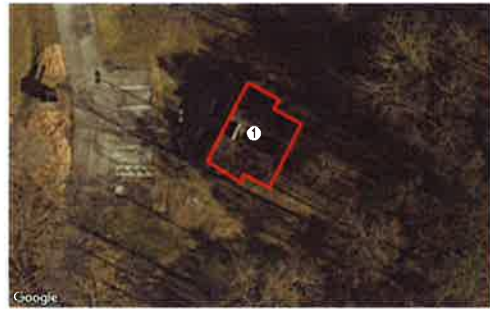
Membrane: F
Flashings: F
Sheet Metal: F

C.L. Burks recommends replacing the existing roof system. The shingle and flat roofs are beyond their useful life.

C.L. Burks recommends completing repairs in this report to maintain roof until a budget is set for replacement.

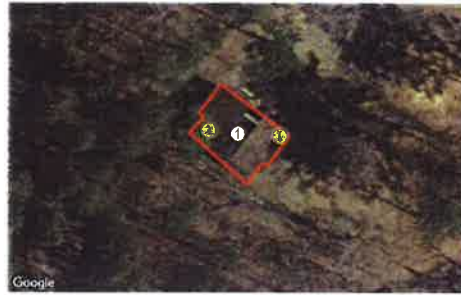
General - Missing Shingles (Remedial)

Quantity: 12 EA
Deficiency:
Missing Shingles
Corrective Action:
Add shingles where it is needed.

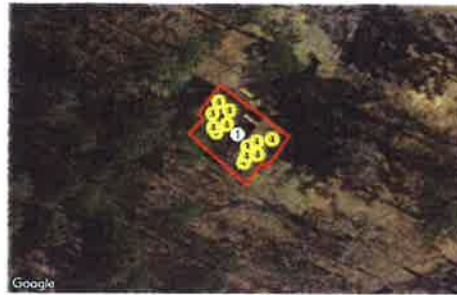
General - Penetration Failure (Emergency)

Quantity: 3 EA

Deficiency:

The penetration should be resealed/flushed per industry standards to ensure a water tight seal.

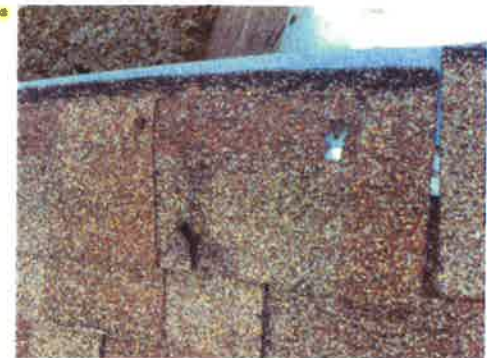
General - Holes - Punctures - Rips - Tears - Splits (Emergency)

Quantity: 16 EA

Hole(s) found in the roofing membrane.

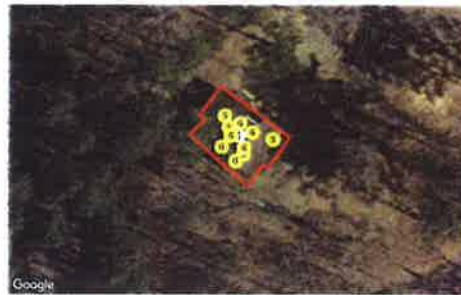
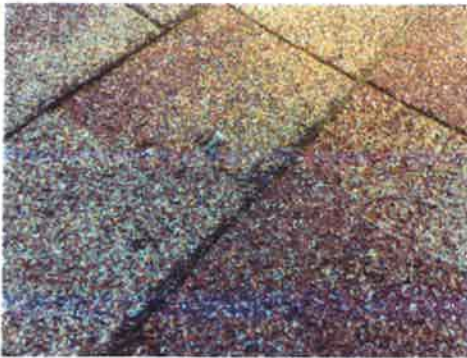
General - Exposed Nails (Emergency)

Quantity: 50 EA

Deficiency:

Drive nails back in and apply sealant

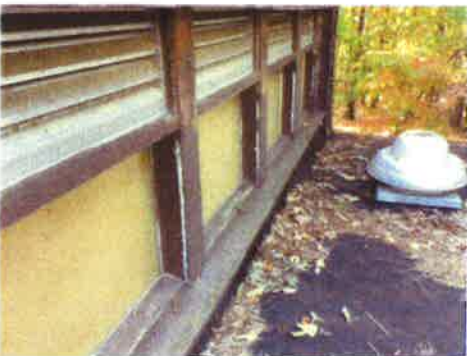
General - Rotten Wood (Remedial)

Quantity: 90 EA

Wooden framing is old and starting to rot.

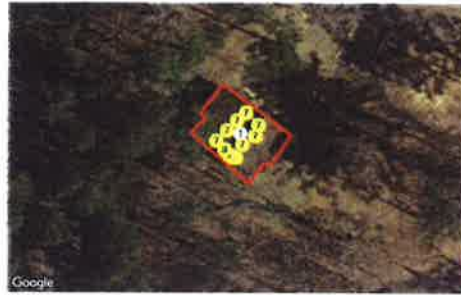
General - Caulking Failure (Remedial)

Quantity: 150 LF

Existing caulking or sealant is deteriorated and is no longer providing a water tight seal.

We will remove the old caulking, clean and prime the areas that are failing, then apply new waterproofing sealant per industry standard to provide a water-tight seal.

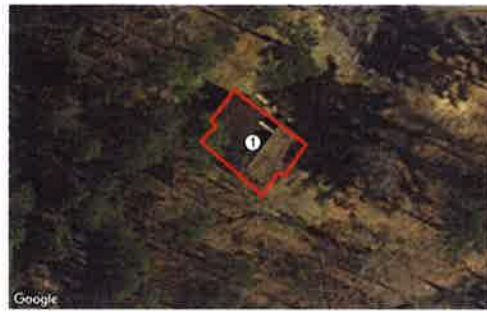
Membrane: F
Flashings: F
Sheet Metal: F

C.L. Burks recommends replacing the existing roof system. The shingle and flat roofs are beyond their useful life.
